NASA TECHNICAL NOTE

NASA TN D-4526

THE USE OF THE ELECTRON PROBE MICROANALYZER IN MATERIALS RESEARCH AND DEVELOPMENT

by Lawrence Kobren
Goddard Space Flight Center
Greenbelt, Md.

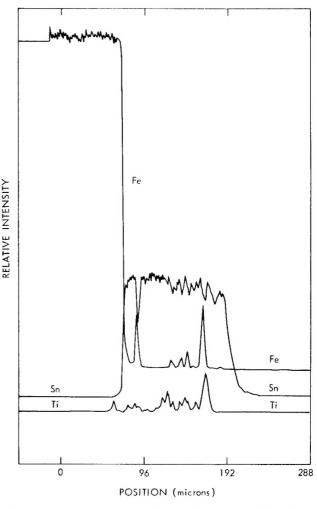
Figure 6—Intensity of Fe, Ti, and Sn versus position for as brazed specimen.

Figures 6 and 7 show the intensities of iron, titanium, and tin plotted against position across the bond. Figure 6 is a plot of a PbTe-Fe couple in the brazed condition; the iron is still distributed inhomogeneously across the braze zone and appears to peak at the SnTe-PbTe interface. The titanium appears to be associated with particles of iron since the titanium and iron peaks generally coincide. The tin on the other hand, remains uniform across the braze zone and drops sharply at the PbTe-SnTe interface. Figure 7 is an intensity-position plot of a specimen which was run at 900°F for 5904 hours. Again, it can be seen that the iron and titanium coincide and are again distributed inhomogeneously throughout the braze zone. The tin, however, shows a diffusion gradient, a gradual reduction

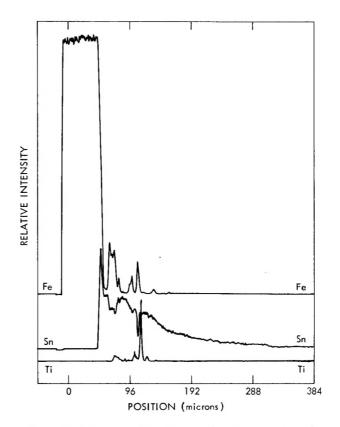
Figure 7-Intensity of Fe, Ti, and Sn versus position for 900°F, 5904-hour test specimen.

across the braze zone, with considerable intensity evident up to 240 microns into the PbTe. It is believed that the diffusion of tin is one of the factors leading to the degradation in the power output of some PbTe thermoelectric elements.

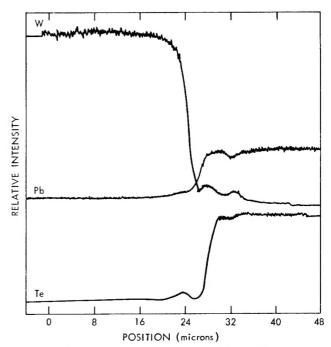
Figure 8 shows an intensity profile trace of W-L α , Pb-L α , and Te-L α X-rays versus position which was made across the bond interface. There is an indication of definite diffusion of tungsten into the PbTe element to a distance of approximately 4 microns. It is also evident that there are no intermediate compounds formed between W, Pb, or Te in the bond zone. This confirms the results of Bates et al.; that is, there is no reaction between the tungsten and the PbTe. Since a strong bond is formed, it is obvious that something other than a PbTe-W reaction takes place. It is theorized that oxygen in the PbTe may take part in the bond reaction, or that dopants in the PbTe may react.

Figure 8-Intensity profile trace of W-L α , Pb-L α , and Te-L α X-rays versus position across bond interface.

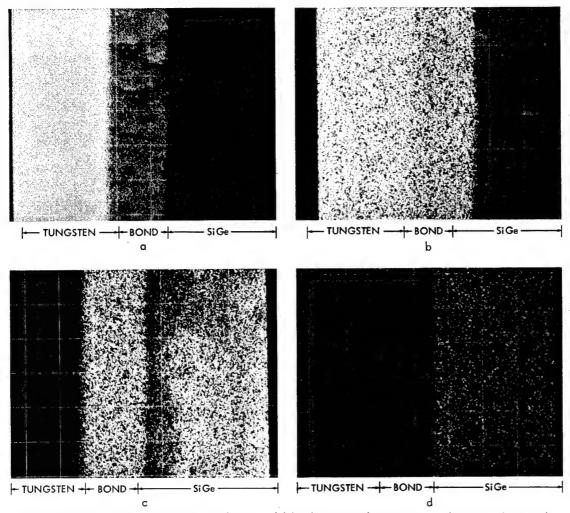
The backscatter electron presentation, Figure 10a, shows the bond zone quite clearly. The picture is biased electronically toward the heavier elements; therefore, the SiGe, whose average atomic number is less than that of tungsten, does not show up. Figure 10b-10d are $WL\alpha$, $SiK\alpha$, and $GeL\alpha$ X-ray scans of the same areas as shown in 10a. Note the presence of silicon and tungsten and the absence of germanium in the bond zone. Also, note the area on the SiGe side of the bond zone (Figure 10c) which is depleted in silicon.

Figure 10–SiGe-W diffusion-bonded element; (a) backscatter electron image biased to heavy elements; horizontal scale = 10μ per division; (b) tungsten L α X-ray scan, same area as (a); (c) silicon K α X-ray scan, same area as (a) showing depletion of silicon on SiGe side of bond zone; (d) germanium K α scan, same area as (a).

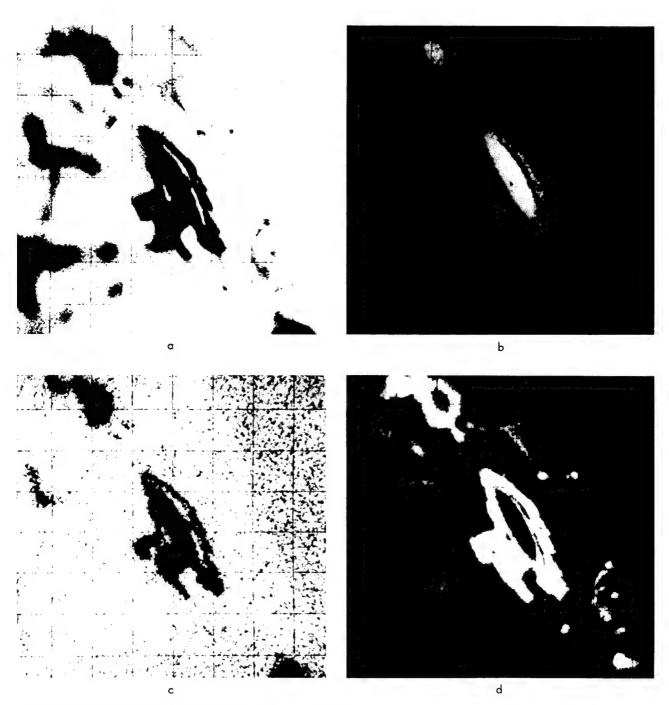
Figure 11—Specimen of PbTe containing molybdenum wire, $170\,\mu$ from cold side of braze zone; horizontal scale = $40\,\mu$ per division; (a) backscatter electron image; (b) Mo–La X-ray scan showing diffusion of Mo into PbTe matrix; (c) Te–La X-ray scan; compare with (b) and note presence of Te in same area as Mo; (d) Fe–Ka X-ray scan showing concentration of iron in reaction zone around Mo wire.

diffusion of molybdenum into the PbTe matrix. A tellurium X-ray scan, Figure 11c, shows the presence of tellurium in the same areas as was observed with molybdenum. In addition, the area around the wire appears to act as a sink for iron since, even 170 microns from the PbTe-SnTe interface, considerable iron was observed. This situation is shown in Figure 11d, which is a FeKa X-ray scan of the same areas as Figure 11a. Notice that iron, tellurium, and molybdenum are concentrated in the reaction zone. No diffusion of iron or tellurium into the molybdenum wire was observed, however. Similar results were observed during an examination of wire near the hotside braze zone. These results are shown in Figures 12a through 12d. Figure 12a is a backscatter electron image with a line profile trace of molybdenum and tellurium superimposed upon it. Molybdenum increases in intensity at point A outside of the wire itself, and the intensity of tellurium increases sharply at the same point, indicating a concentration of tellurium there (the path of the electron beam is indicated by the horizontal line across the center of the picture). The intensity profiles are artificially displaced from this line for clarity. It is apparent that the reaction zone forms at a fairly low temperature (400°F), although at higher temperatures the reaction zone is more distinctive (compare Figure 12 with Figure 11). For wires that were far removed from the bond zone, there was no evidence of iron in the reaction zone; however, tellurium and molybdenum do continue to react. The strengthening effect noted by the addition of the molybdenum wire to the PbTe is believed to be caused by the removal of excess tellurium from the matrix (Reference 6); however, long-term tests have not been performed, and it is not known how the electrical properties are affected by this addition.

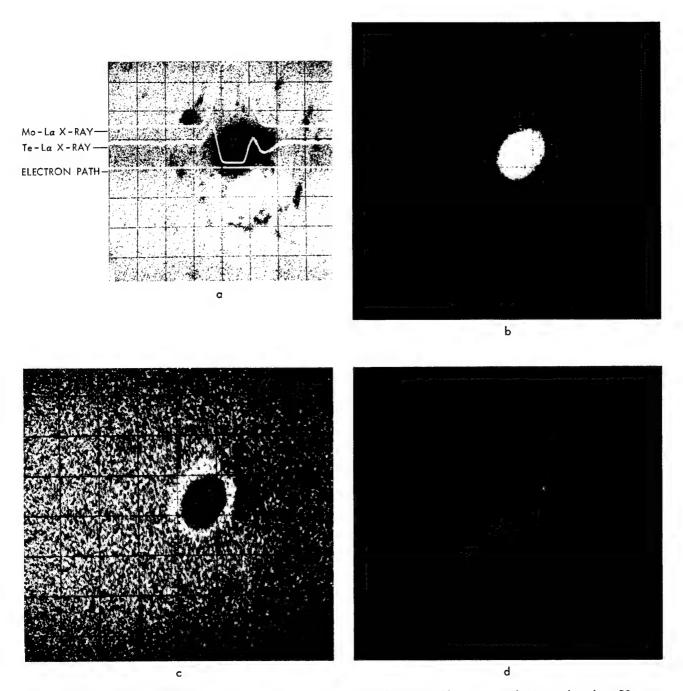
Figure 12–Specimen of PbTe containing molybdenum wire, near hot side of braze zone; horizontal scale = 20μ per division; (a) backscatter electron image with superimposed line profile traces of Mo-L α , and Te-L α X-ray intensities; (b) Mo-L α X-ray scan showing diffusion of Mo into PbTe matrix; (c) Te-L α X-ray scan showing concentration of Te around wire; (d) Fe-K α X-ray scan showing Fe concentration in reaction zone around Mo wire.

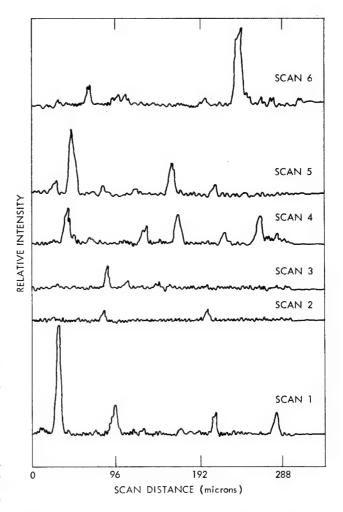
the typical analysis content to amounts containing as much as 35 percent iron. It can be seen that the peak iron concentrations generally lie in line with one another within the area scanned. An iron $K\alpha$ X-ray scan near the end of one of the corrosion pits was made and is shown in Figure 15. The inhomogeneous distribution of iron is plainly evident. It is believed that the iron in these areas was attacked by the nitric acid during passivation, causing the corrosion pits which are the most likely path for leakage of the H_2O_2 .

Figure 14–Fe intensity versus probe position over analysis area of 1060 aluminum containing corrosion pits; six scans, 100μ apart, are shown.

The problem was solved by annealing the material at 1100°F for 16 hours. This treatment resulted in a more homogeneous distribution of iron and thereby prevented the formation of corrosion pits.

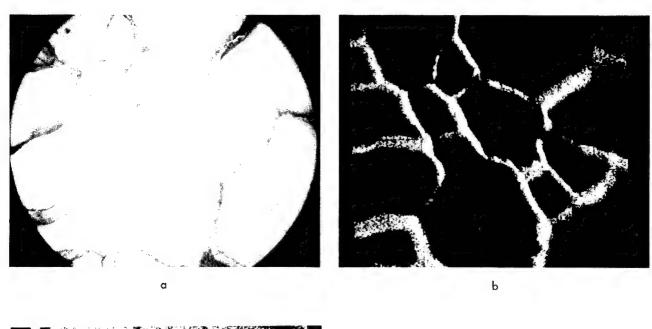
Figure 15–Fe–K α X–ray scan of 1060 aluminum near tip of corrosion pit; horizontal scale = 5μ per division.

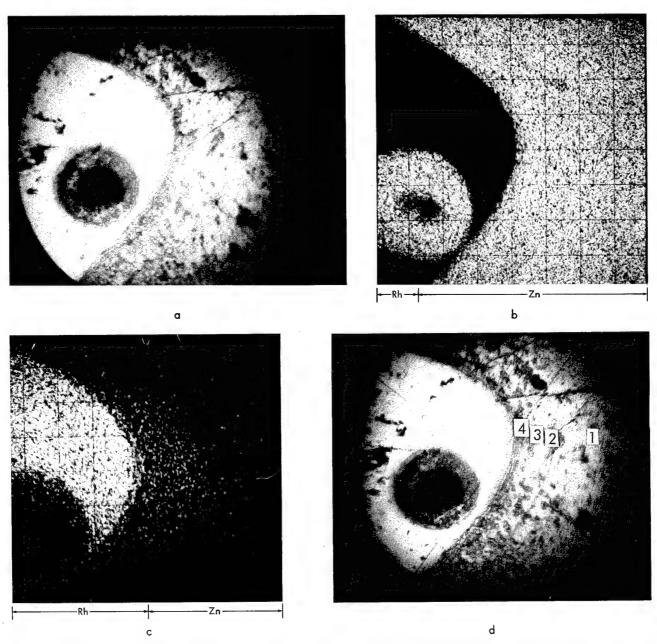
Figure 17—Analysis of rhodium-zinc system; (a) photomicrograph (250X); (b) Zn-K α X-ray scan of same area, showing absence of appreciable zinc in Rh zone; horizontal scale = 40μ per division; (c) Rh-L α X-ray scan of same area, showing diffusion of Rh into Zn area; (d) photomicrograph (250X) showing zones in the Zn matrix which were quantitatively analyzed for Zn.

other area was apparently zinc which had melted and solidified. Electron probe examination, Figure 17b, which is a zinc $K\alpha$ X-ray scan of the area shown in Figure 17a, showed a sharp separation between the two areas with little or no diffusion of zinc into the rhodium. The circular concentration of zinc in the rhodium is believed to have resulted from a hole in the rhodium into which the molten zinc flowed during the heat treatment. Figure 17c, the rhodium X-ray scan, shows an apparent diffusion of rhodium into the zinc. A semi-quantitative analysis of this apparent diffusion zone was made at a different distance from the interface, outward as shown in Figure 17d. The intensity ratios I/Io for zinc uncorrected for absorption effects are as follows:

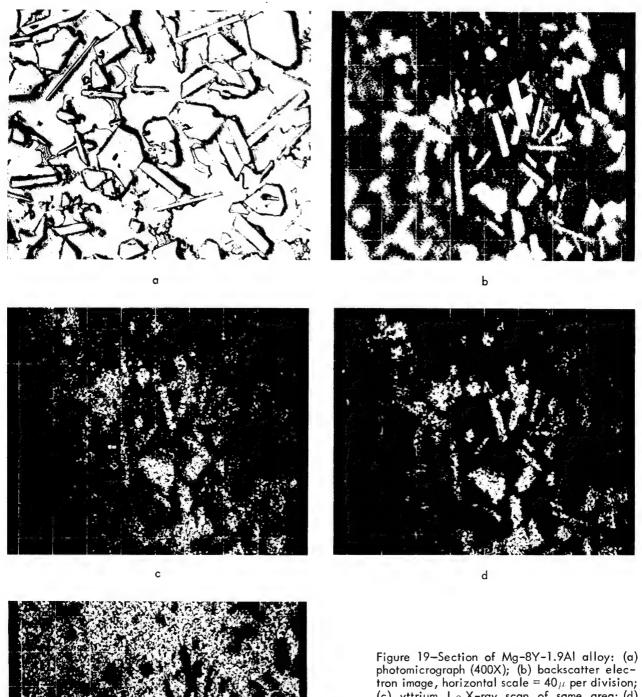
Metallographic examination of a Mg-8Y-1.9A1 alloy is shown in Figure 19a. It can be observed that there is a two-phase field with one phase consisting of highly discrete, massive particles surrounded by a uniformly distributed, second-phase matrix. Electron probe examination was performed to determine the compositions of these phases. Figure 19b shows a backscatter electron image of a Mg-8Y-1.9A1 specimen. Notice that the particles are brighter than the matrix, indicating a material of heavier atomic number than the matrix. Figures 19c, 19d, and 19e are Y-Llpha, A1-Klpha, and Mg-KlphaX-ray scans of the specimen. It is readily seen that the particles are primarily an yttrium-aluminum compound, whereas the matrix is primarily magnesium. Semiquantitative analysis verifies these results, indicating that the major constituents of the particles are yttrium and aluminum, with only 1.3 percent aluminum in the magnesium matrix. There is also some indication that the Y-Al particles contain some carbon and oxygen although the amounts present are less than 1 percent. Similar results were obtained with a Mg-2Y-7.9A1 alloy. The intermetallic particles in this sample appeared to have approximately the same amount of aluminum and yttrium as the first sample, and it was obvious that a Y-Al compound was formed just as in the first rather than a homogeneous solution of yttrium and aluminum in magnesium. The presence of the Y-Al intermetallic compound corresponds quite well to that of the Y-Al compounds described in the phase diagram given by Elliott (Reference 11). It is obvious that yttrium and aluminum are combining during the melting, preventing the complete solution of these compounds in the alloy. Since the Y-Al intermetallic compound is an inherent part of the system, efforts are being formulated to use this as a strengthening agent in the alloy. To do this, the intermetallic must be made much smaller in size and should be distributed more homogeneously within the alloy. One method to accomplish this is to formulate the alloy from powder products. This method is being contemplated for future work.

Figure 19–Section of Mg–8Y–1.9Al alloy: (a) photomicrograph (400X); (b) backscatter electron image, horizontal scale = $40\,\mu$ per division; (c) yttrium L α X–ray scan of same area; (d) aluminum K α X–ray scan of same area; (e) magnesium K α X–ray scan of same area.

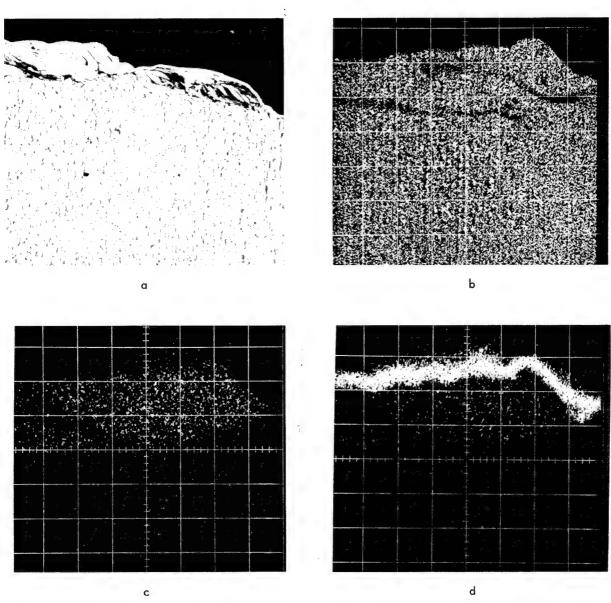
Figure 20—Portion of surface of a 1020 steel rider which had been rubbed against a 4320 steel plate: (a) photomicrograph (250X); (b) backscatter electron image; horizontal scale = 40μ per division; (c) chromium K α X-ray scan of same area; (d) nickel K α X-ray scan of same area, showing nickel plating on surface and in area coinciding with that of the chromium in (c).

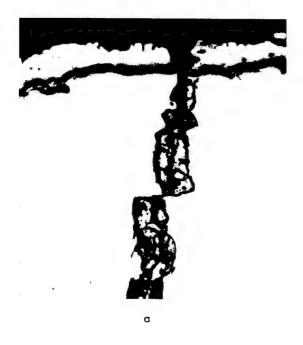
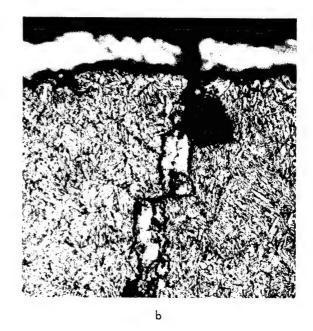
Figure 23—Transverse crack in nonetched (a) and nitaletched (b) conditions at 500X to show tin in crack. The electron microprobe photograph (c) identifies tin. The scan does not fully reach the surface in this case to reveal the tin plating.

Examination of the crack at high magnification revealed the presence of tin, as shown in Figure 23a and 23b. An electron probe examination of the crack using a tin X-ray scan revealed the presence of tin in the crack (Figure 23c). Tin X-ray scans were also made at the tip of the crack to determine whether tin had penetrated to this point. An example of one of the crack tips is shown in Figure 24a; the tin X-ray scan is shown in Figure 24b, which shows tin penetration even to the crack tip.

It is believed that the throwing power of the tin-plating solution was not sufficient to deposit tin at the tip of an already existing crack. Therefore, the crack is believed to have resulted from intergranular penetration by the tin into the highly stressed steel during the hydrogen stress-relieving operation which was conducted after the tin was applied. On the basis of this analysis, Babecki and Jellison (Reference 12) concluded that on future springs of this design, a more effective stress relief be effectuated by a combination of higher temperature and longer times. Also they concluded that if tin plating is continued, care should be taken to insure that the melting point of tin is not attained during any step in the fabrication process.
